**PRELIMINARY ASSESSMENT/
VISUAL SITE INSPECTION**

**AMERICAN STEEL AND WIRE CORPORATION
CUYAHOGA HEIGHTS, OHIO
OHD 004 220 810**

**FORMERLY U.S. STEEL CORPORATION
CUYAHOGA PLANT**

FINAL REPORT

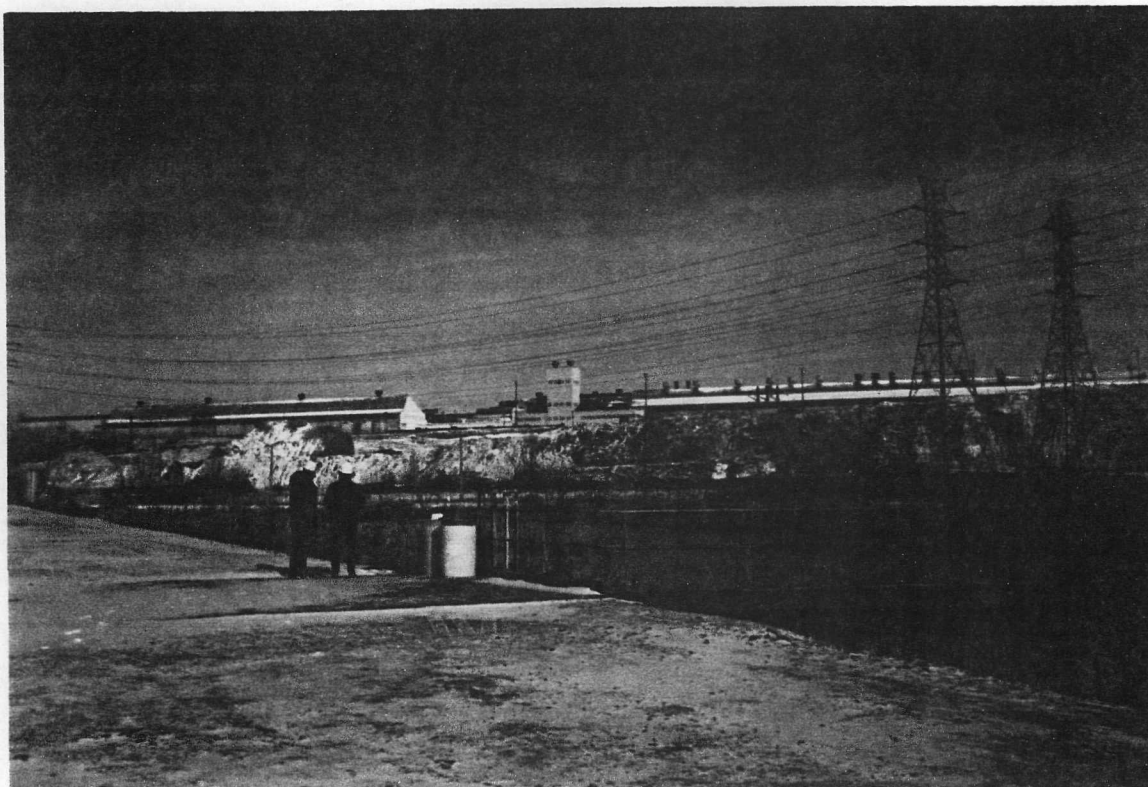
Photograph No. 1

Observations:	The lagoon contained wastewater with a noticeable oily sheen. The lagoon's earthen embankments showed no signs of erosion, and the concrete dam was free of any cracks. Some vegetation was observed growing on sections of the earthen dikes. No discharge was observed.
SWMU 2	
Unit Description:	Sludge Drying Beds The sludge drying beds are located adjacent to the wastewater treatment lagoon (SWMU 1). The beds are used to dewater sludge removed from the lagoon. There is a total of four beds. Each bed is approximately 12 feet wide, 30 to 40 feet long, and 8 feet deep. The beds contain drainage tile to convey water back to the treatment lagoon. Approximately 10,313 cubic yards of sludge remain in the unit (ASW, 1991d). Three or four ground-water monitoring wells are located next to the beds but are not currently in use (see photograph nos. 3 and 4). OEPA required ASW to conduct some initial ground-water monitoring after construction of the beds. ASW could not provide any monitoring data -- facility representatives indicated that monitoring of the wells ceased in 1986.

Location: SWMU 1

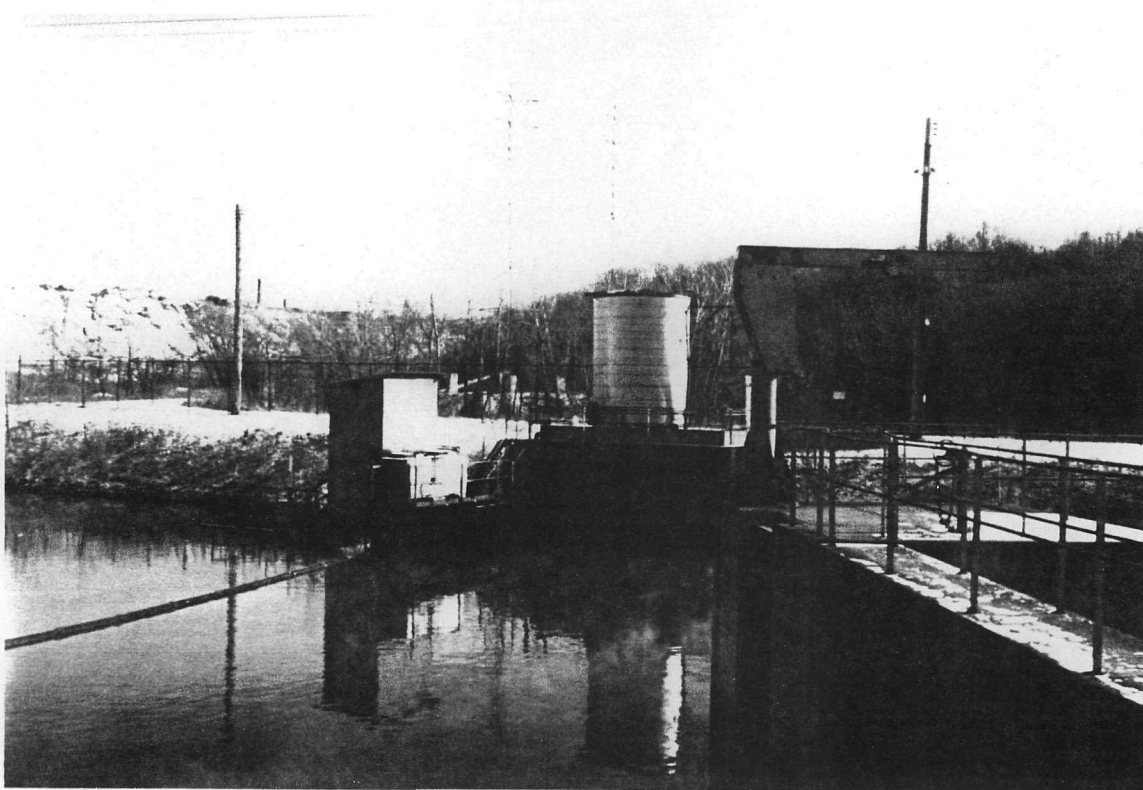
Photograph No. 2

Location: SWMU 1

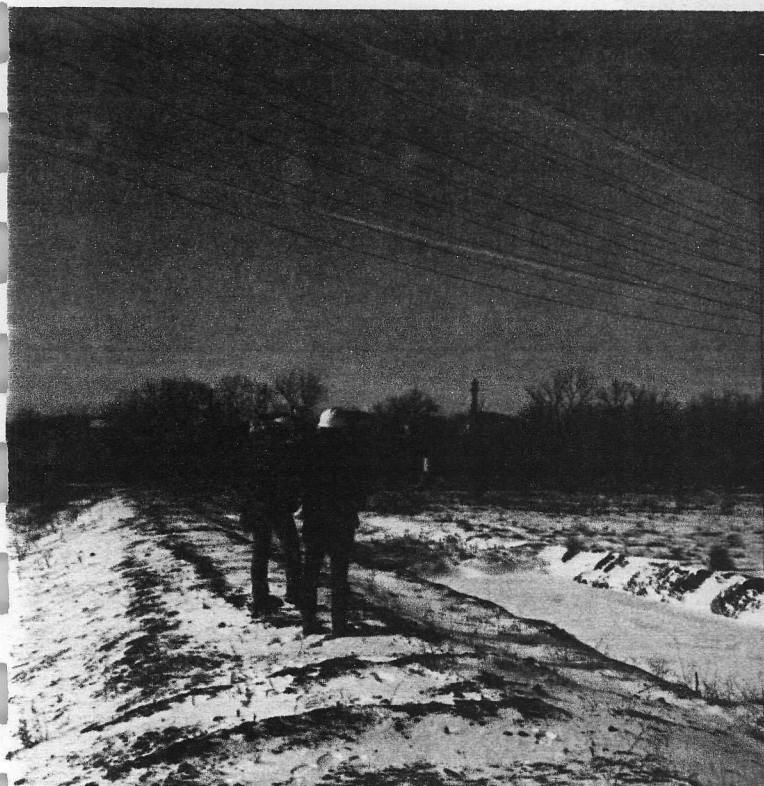
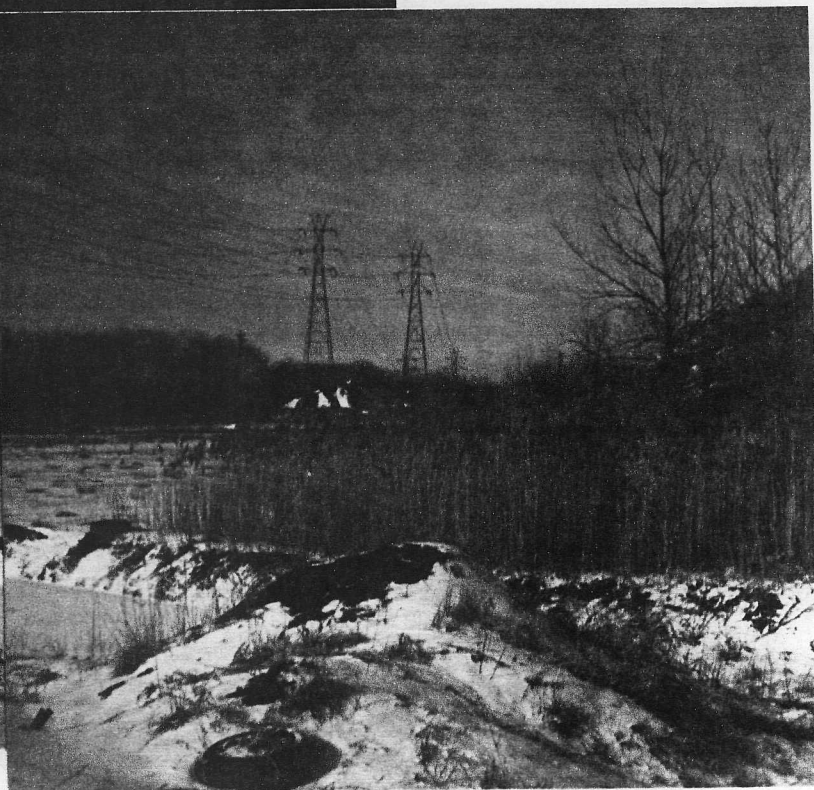
Photograph No. 3

Location: SWMU 2

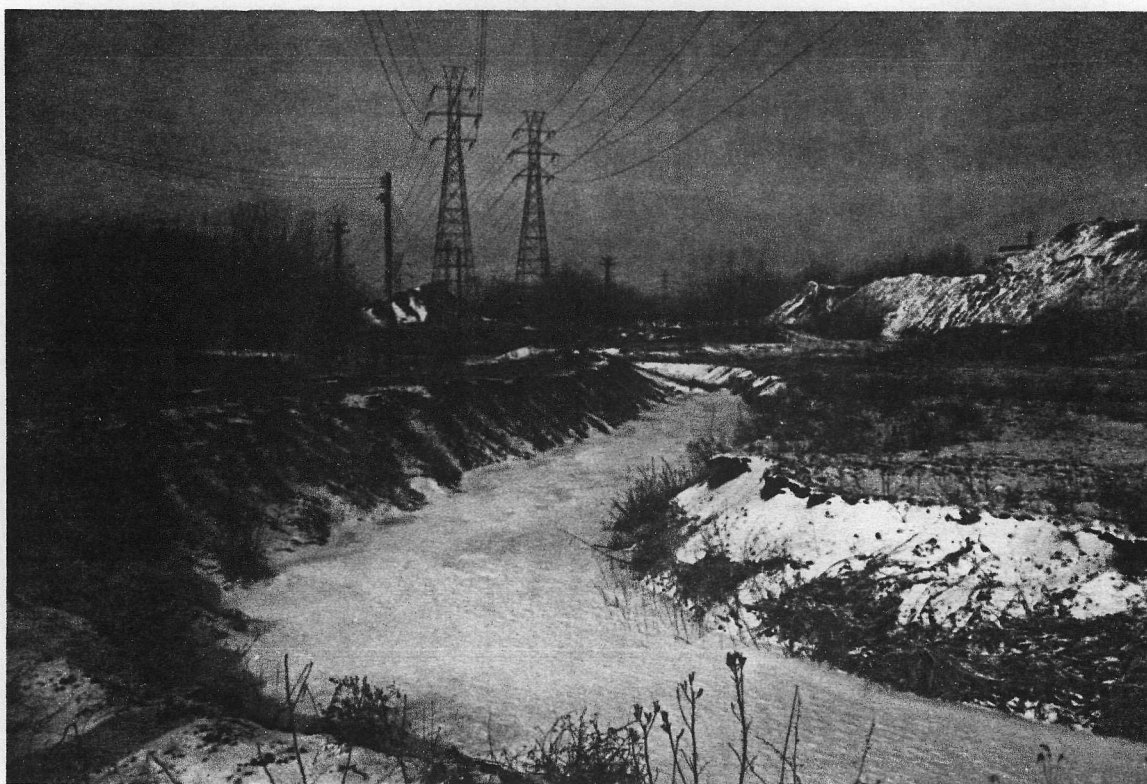
Photograph No. 4

Location: SWMU 2

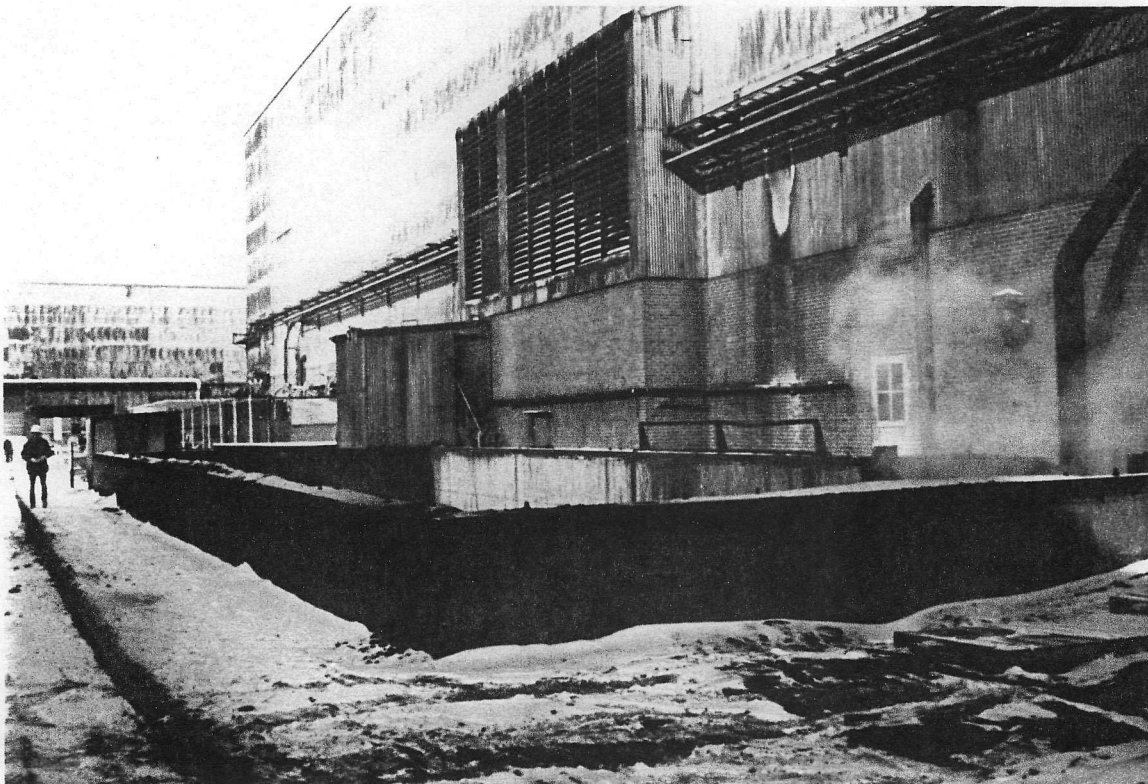
Photograph No. 5
Orientation: West
Description: Top of the scale pit.

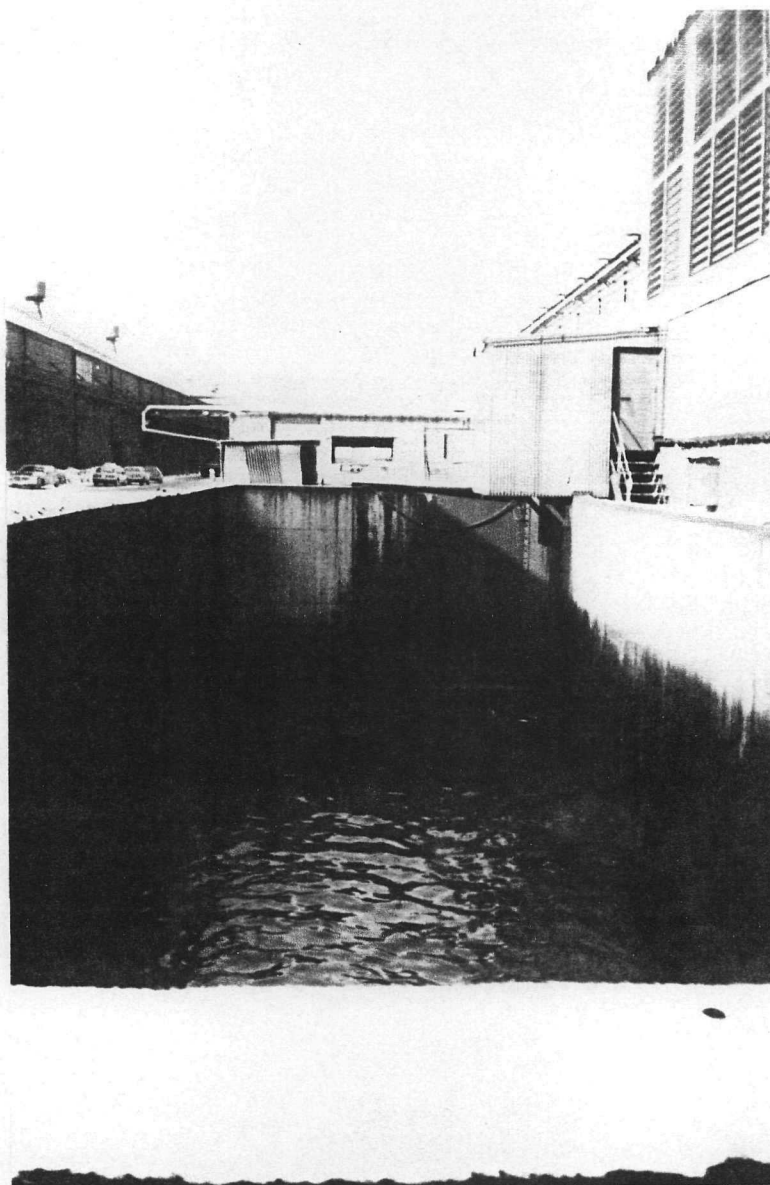
The concrete sidewalls of the pit did not have any noticeable cracks. Wastewater was flowing through the pit during the VSI, so it was not possible to inspect the bottom of the pit. The pit had adequate freeboard to prevent overtopping.

Photograph No. 6
Orientation: West
Description: Inside of the scale pit.

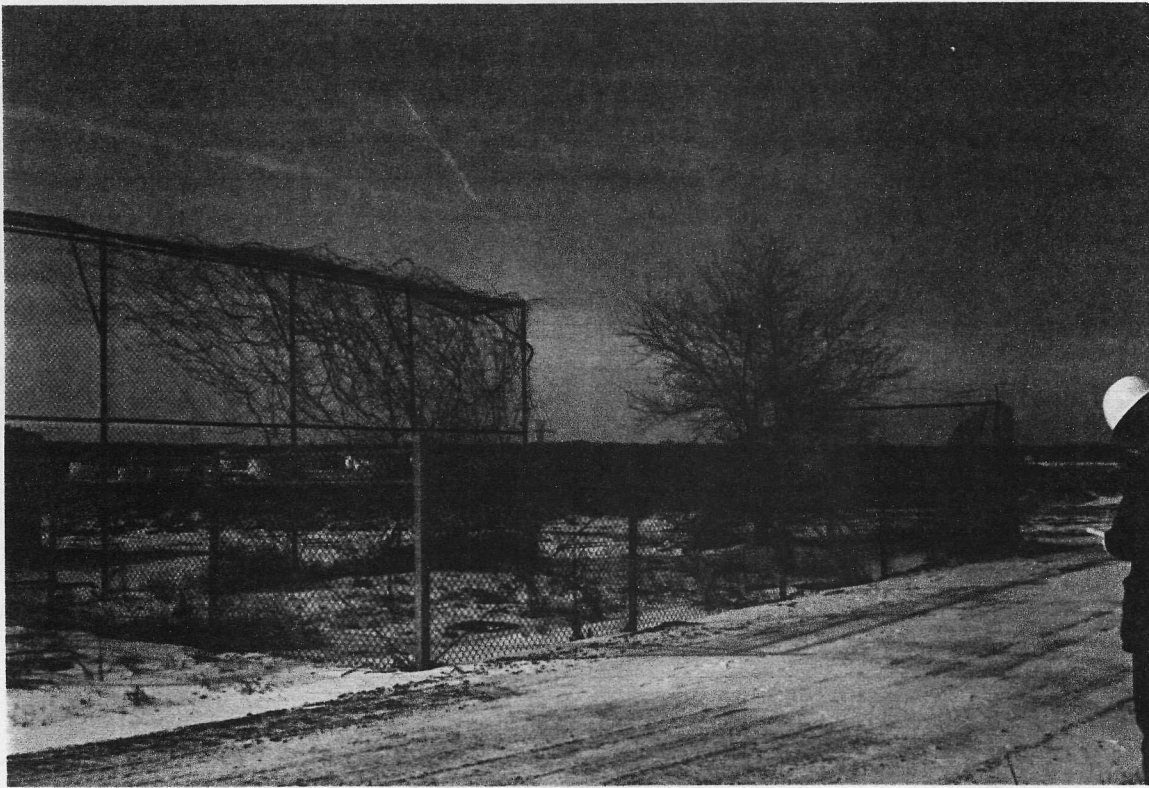
The former hazardous waste drum storage area is located near the edge of a bluff that runs across the facility. The unit formerly was used by US Steel-Cuyahoga Plant to store drums containing hazardous waste generated by the facility. The storage area consisted of a 1,250-square-foot area completely surrounded by a fence. Sealed 55-gallon drums were stored upright in a single layer on bare ground within the fenced area. The design capacity of the unit was fifty 55-gallon drums (see photograph no. 7) (USS, 1984).

Observations: No drums containing wastes were present in the former storage area during the VSI. A corroded and damaged empty drum was observed inside the former drum storage area. The fence surrounding the unit was in disarray. Vegetation and evidence of sampling boreholes were seen inside the former storage area.

Photograph No. 7 **Location:** SWMU 4
Orientation: Southwest **Date:** February 12, 1992
Description: View of the former hazardous waste drum storage area used between 1980 and 1984.

Recommendations: PRC recommends that sampling be conducted at the unit in accordance with the facility's approved closure plan and contaminated soils found to be excavated and disposed of offsite.

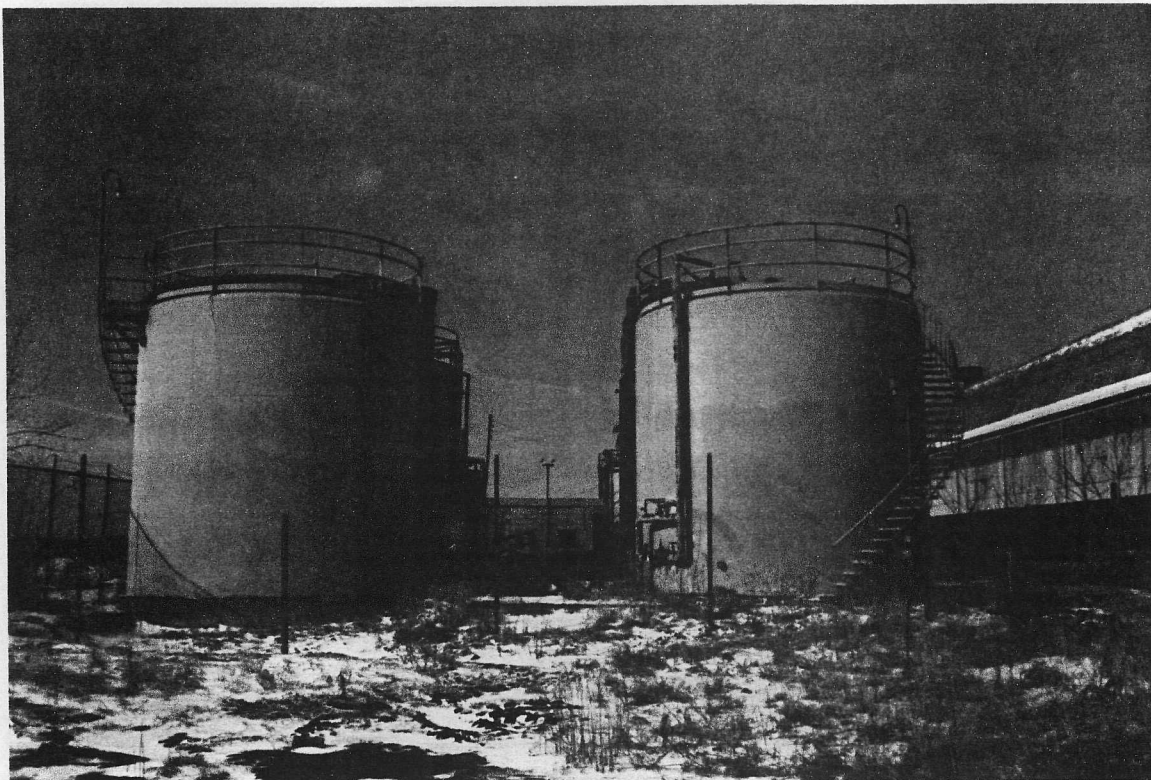
Unit Description: The former hazardous waste tank farm is located near the edge of a bluff that runs through the facility. The tank farm formerly was used by US Steel-Cuyahoga Plant to temporarily store spent pickle liquor (K062) before the waste was shipped off site for disposal or reuse as a treatment chemical in a POTW. The tank farm consists of four 40,000-gallon carbon steel storage tanks lined with acid-resistant brick and rubber, a pump house, two fiberglass spent pickle liquor collection tanks (approximately 1,000 gallons each) and transfer pumps, rubber-lined interconnection piping, and an acid loading area. At anytime during the operating life of the tank farm, the maximum inventory of waste in storage is 162,000 gallons including the four storage tanks and fiberglass collection tanks. However, because one of the storage tanks was not working during the operation of the tank farm, the available storage capacity was 122,000 gallons instead of 162,000 gallons (USS, 1984). The four storage tanks are located on bare ground covered with crushed slag within a 70- by 100-foot partially enclosed area (see photograph nos. 8, 9, and 10).

Photograph No. 8 **Location:** SWMU 5
Orientation: West **Date:** February 12, 1992
Description: View of the former hazardous waste tank farm.

Recommendations: PRC recommends that sampling be conducted at the unit in accordance with the facility's approved closure plan and contaminated soils found to be excavated and disposed of offsite.

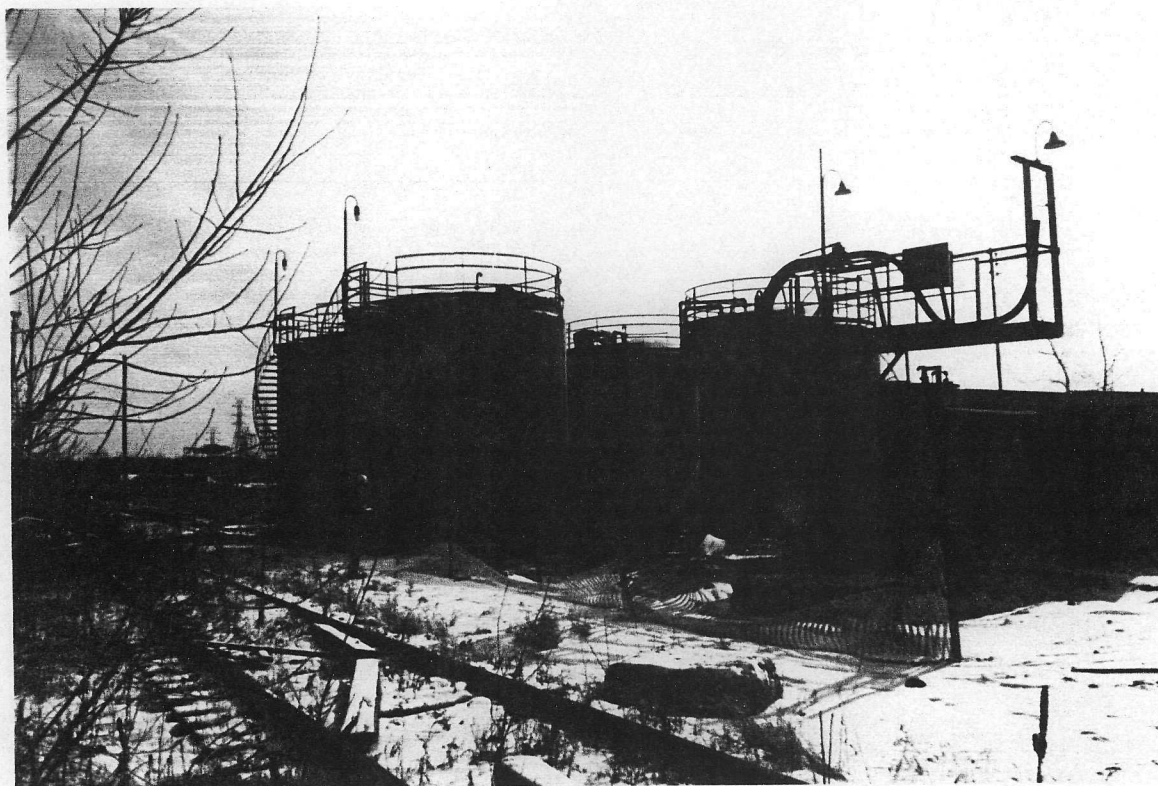
All the piping at the tank farm had been dismantled or disconnected. There were no visible signs of damage or holes in the tanks to indicate that any releases had occurred. However, some of the bare ground within the tank farm area had been excavated and placed into dumpster boxes (SWMU 6) adjacent to the tank farm, suggesting that soils were contaminated from past releases.

Photograph No. 9
Orientation: Southeast
Description: Another view of the former hazardous waste tank farm. Note the excavation and removal of soils surrounding the storage tanks.

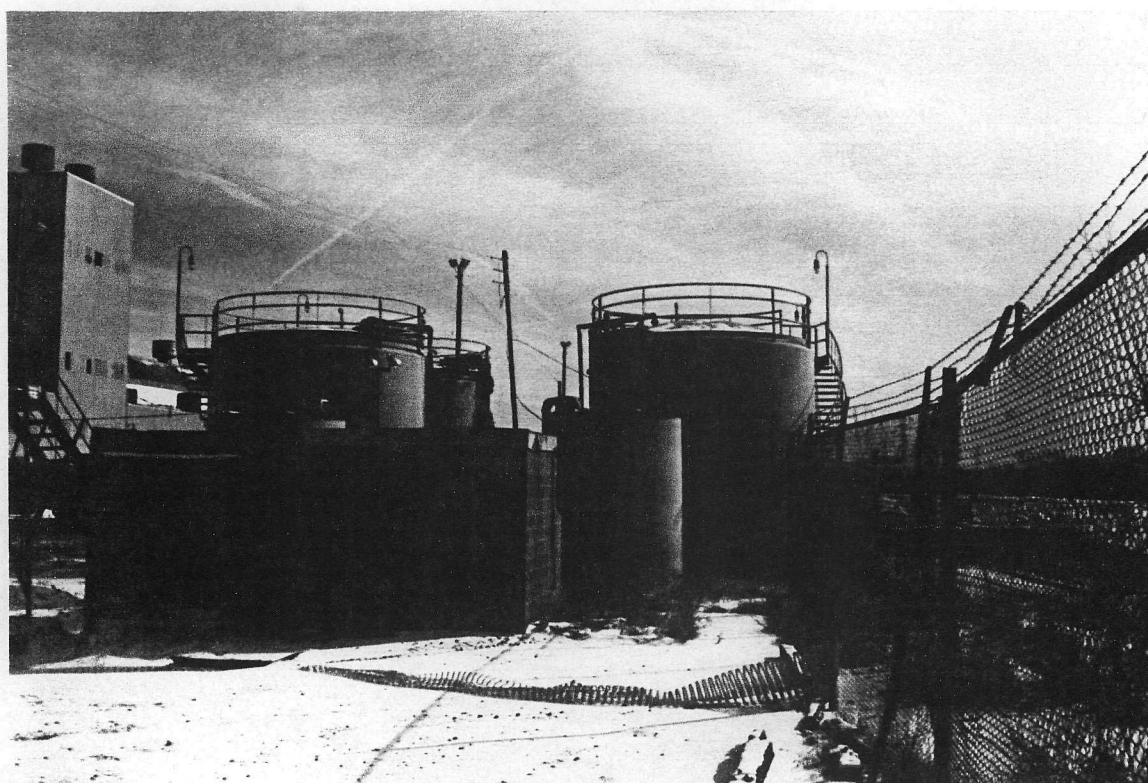
Photograph No. 10
Orientation: East
Description: View of the former hazardous waste tank farm. The cinder block building is the pumphouse.

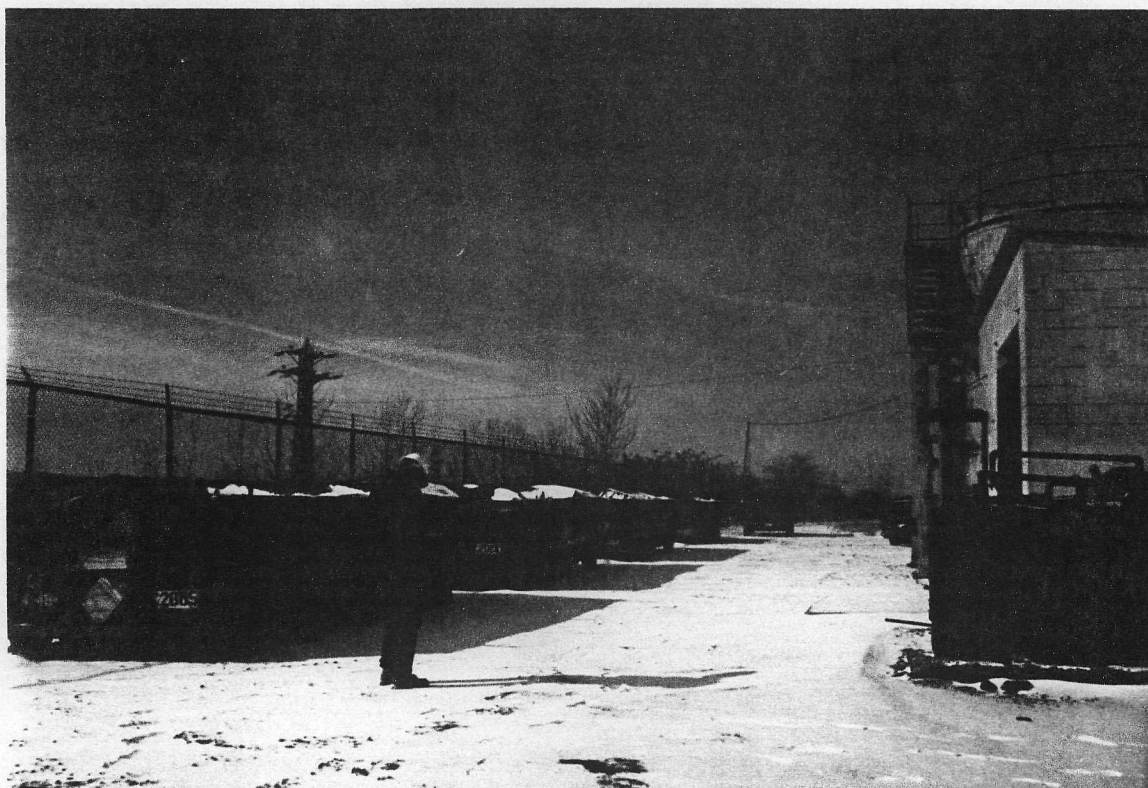
Four steel dumpster (or roll-off boxes) are located near the former hazardous waste tank farm (SWMU 5). The boxes contain excavated soils from the tank farm area. The dumpster boxes are covered with tarps that are secured by bungee cords (see photograph no. 11).

Observations: The dumpster boxes were in good physical condition and the tarps covering the boxes were properly secured. No spills of potentially contaminated soil near the boxes were observed.

Photograph No.	11	Location:	SWMU 6
Orientation:	Southwest	Date:	February 12, 1992
Description:	Dumpster boxes containing potentially contaminated soils excavated from the former hazardous waste tank farm (SWMU 5).

Recommendations: PRC recommends no further action for this SWMU.

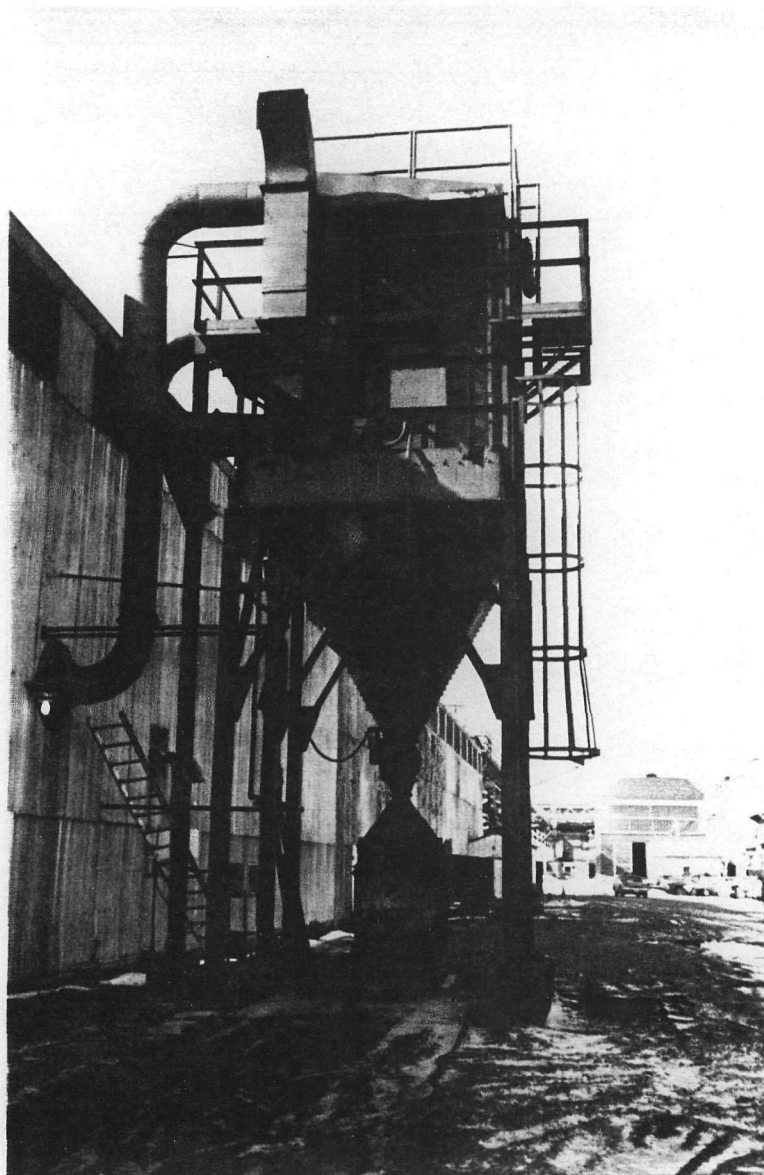
Observations: The unit appeared to be in sound structural shape during the VSI. No evidence of deterioration of the unit was evident.

Photograph No. 12
Orientation: West
Description: View of the baghouse located outside the rod mill.

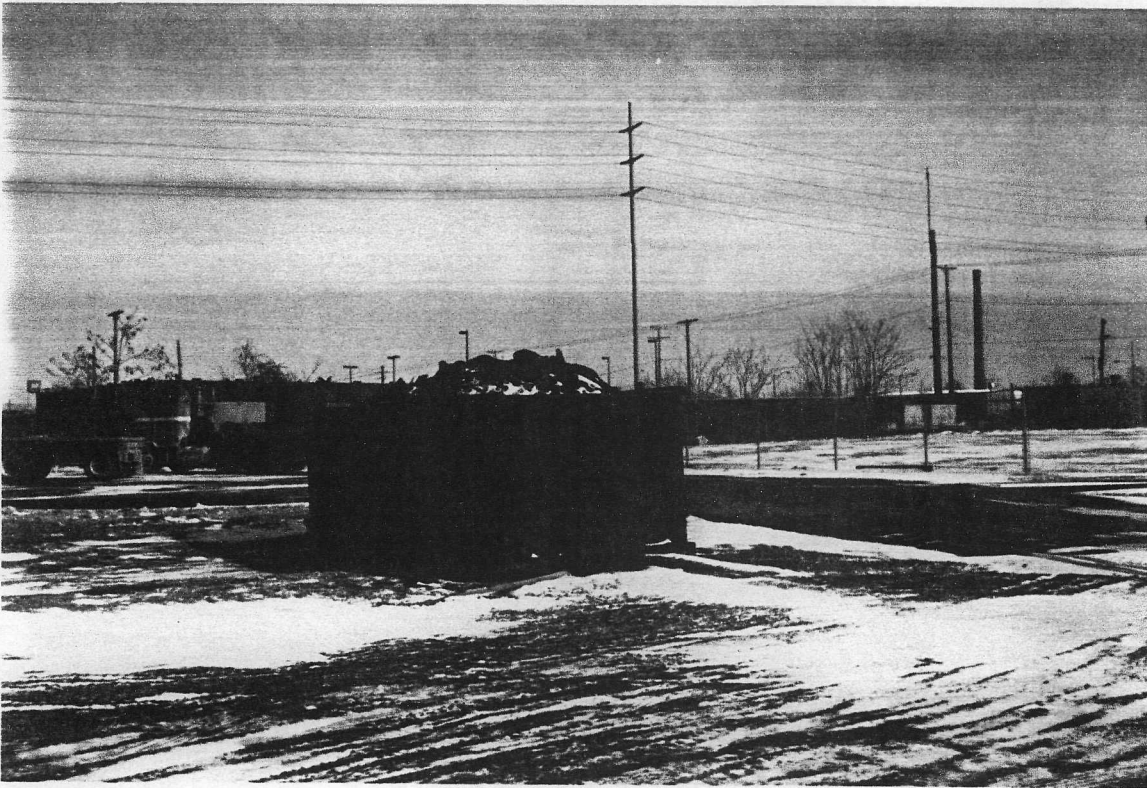
Wastes Managed:	The unit contains swarf and other metal-bearing dusts that do not exhibit the characteristic of toxicity (ASW, 1992a). These materials are sent off site to a recycling facility.
Release Controls:	The unit has no release controls.
History of Documented Releases:	No releases from this SWMU have been documented.
Observations:	The hopper is a portable unit and probably has not been located at this location for more than several months. The hopper appeared old and was rusted and worn. However, there appeared to be no holes or other openings in the unit. The unit lacked a tarp to prevent wind dispersion of finely divided metal particles.

Photograph No. 13 **Location:** SWMU 8
Orientation: North **Date:** February 12, 1992
Description: Hopper containing swarf, scrap metals, and other metal-bearing dusts.

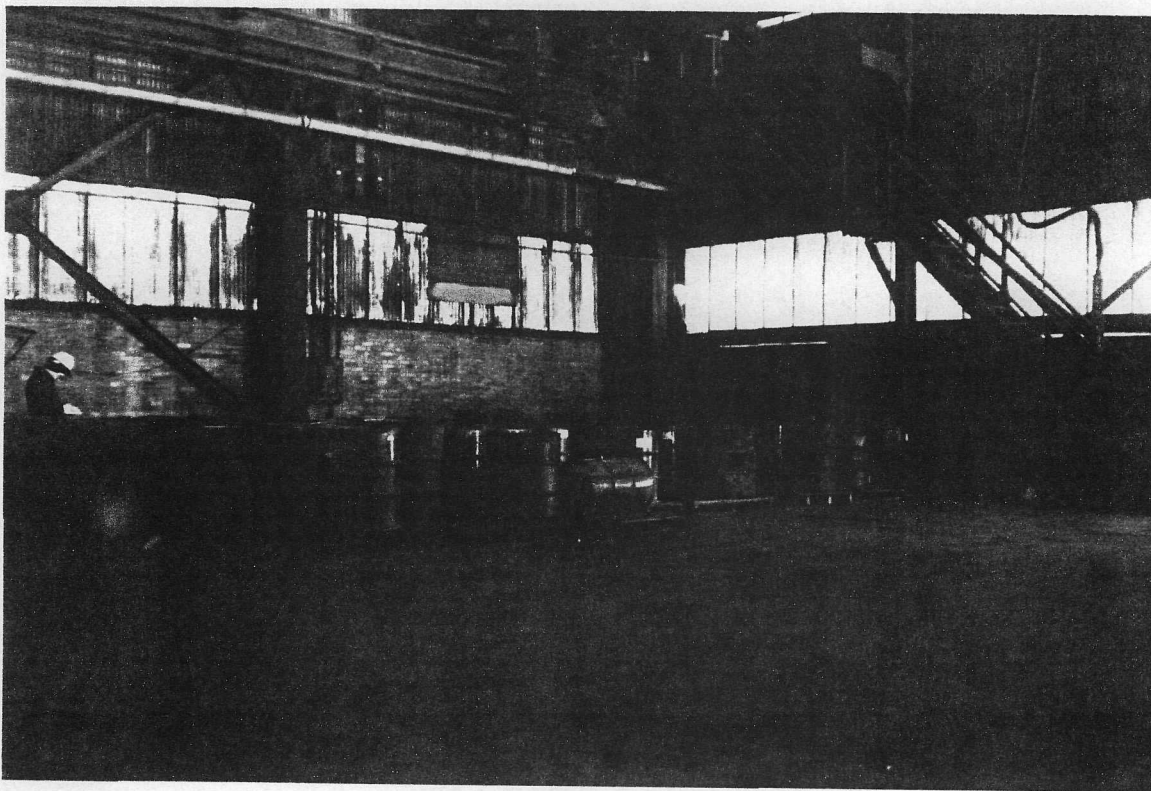
Photograph No. 14 **Location:** SWMU 9
Orientation: Northeast **Date:** February 12, 1992
Description: View of drum storage area 1 located inside old normalizing building.

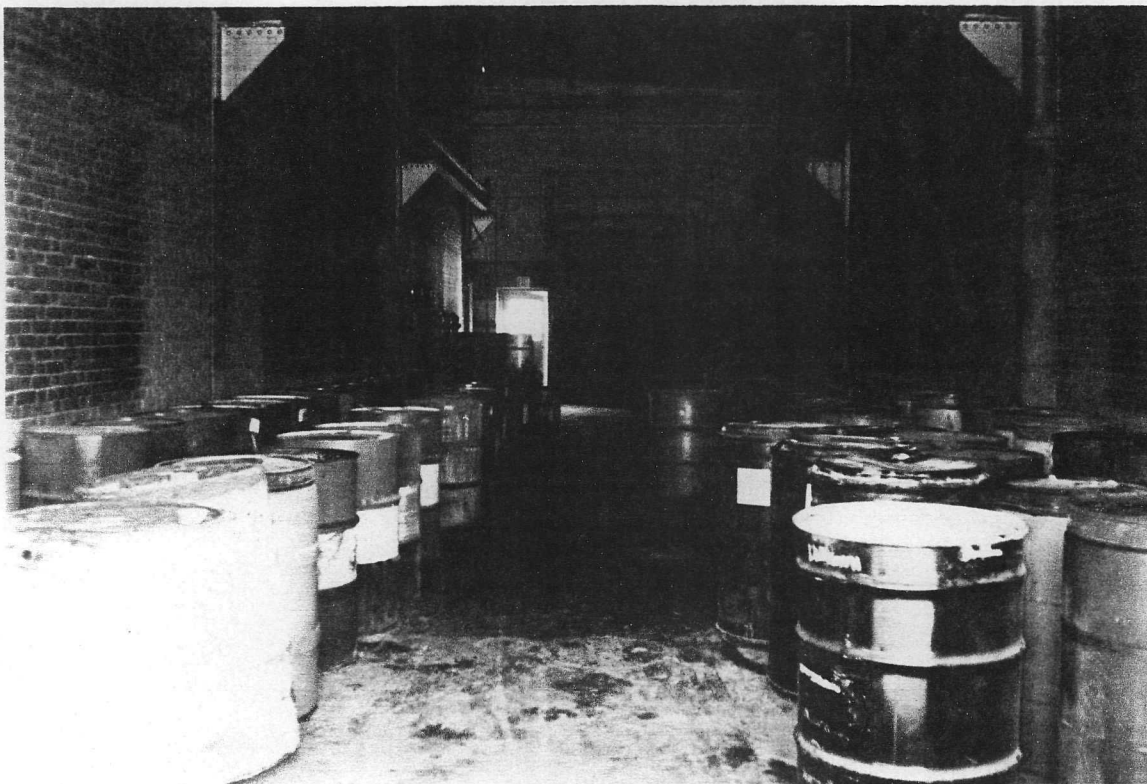
Photograph No. 15
Orientation: East
Description: View of drum storage area 2.

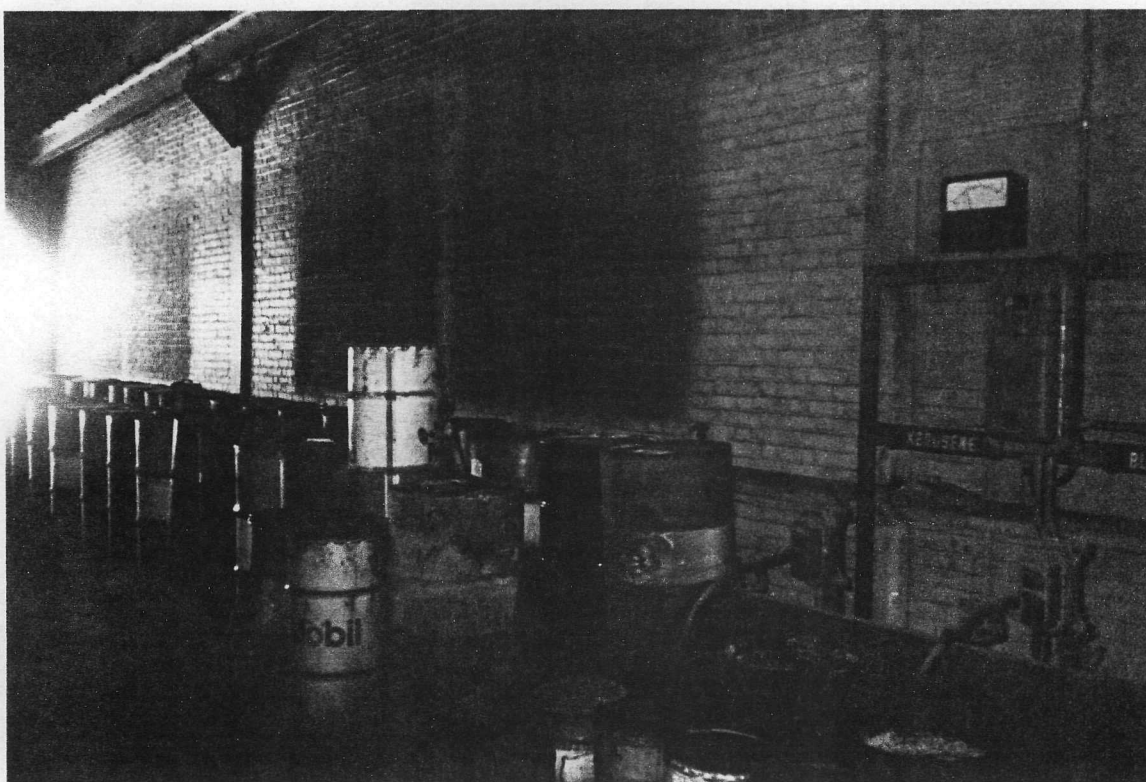
Observations:	The unit contained approximately 50 to 60 drums. There were no visible cracks in the concrete floor. There were no floor drains inside the building. The drums were placed directly on the floor. Some of the drums were in poor condition and appeared as if they had been stored there for some time.

Photograph No. 16
Orientation: Northwest
Description: Another view of drum storage area 2; note the corroded drums.

Recommendations: PRC recommends no further action for this SWMU.

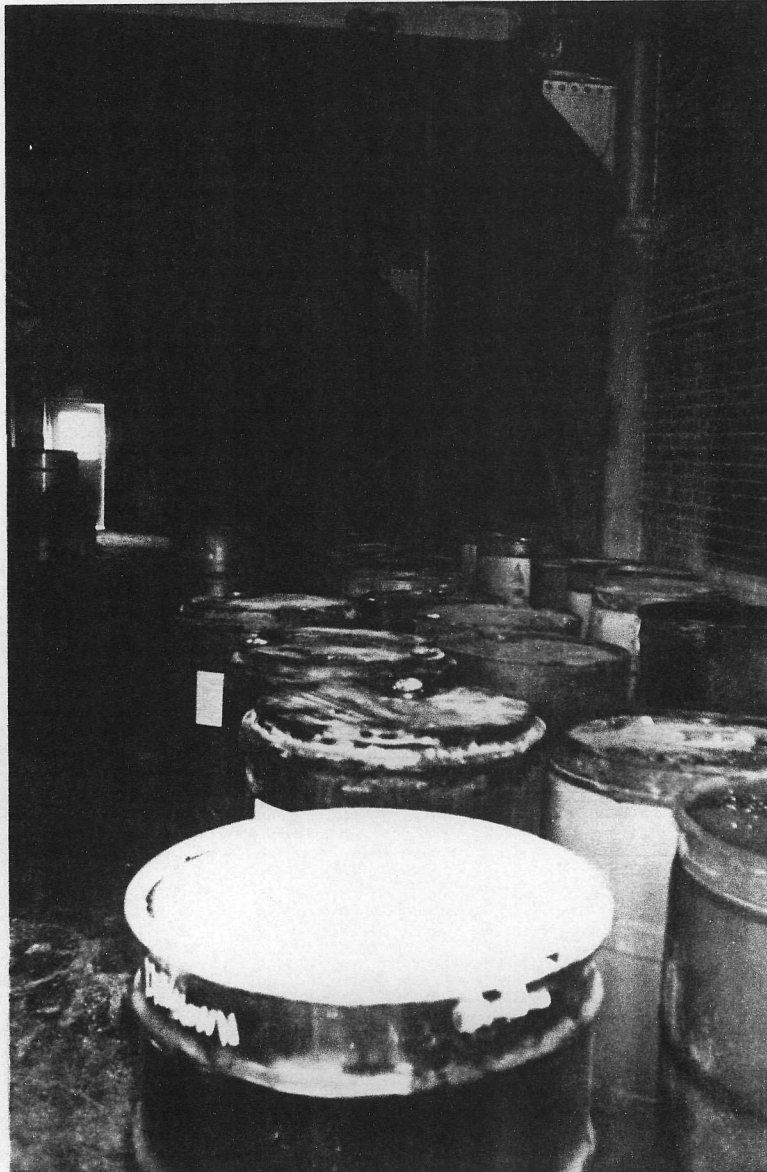
Photograph No. 17
Orientation: East
Description: View of containers located in drum storage area 2.
